# HOME INSPECTION AND REPORT SERVICES

LISTING INSPECTION AT

**15134 MONROE AVE., MOUNTAIN VIEW, CA**

INSPECTION DATE: JANUARY 28<sup>TH</sup>, 2007

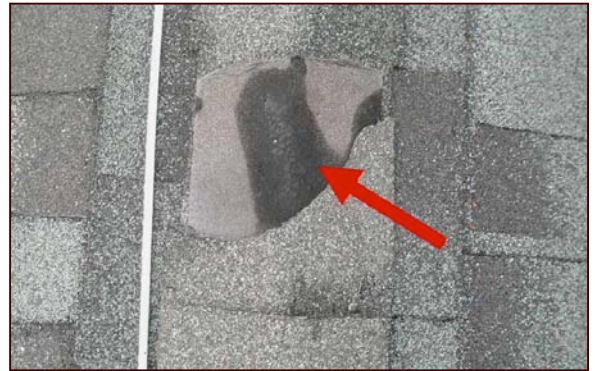
1. A damaged shingle was observed at the ridge of the right front roof (**See the top photo to the right**). The shingle should be repaired or replaced to maintain the roof covering and to help avoid water penetration and possible damage. Exposed nail heads were observed at a front roof ridge area. Sealing the nail heads is recommended as a preventive measure to help avoid water penetration and possible damage. A qualified roofing contractor should evaluate the conditions and perform the necessary corrections.

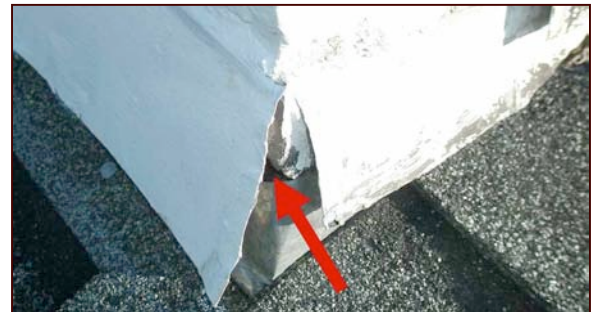
2. Faulty flashing overlaps were observed at the chimney counter flashing (**See the middle photo to the right**). The flashing and seals should be evaluated by a qualified roofing contractor and corrected as needed to assure a proper and leak free installation.

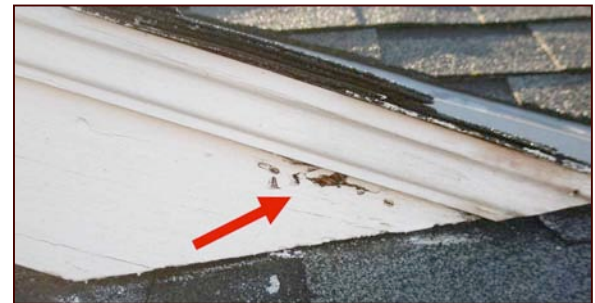
5. Damage (deterioration) was observed at the right end of the front barge rafter on the roof above the garage (**See the bottom photo to the right**). The condition should be evaluated by a qualified contractor and corrected as needed to repair the damaged component.

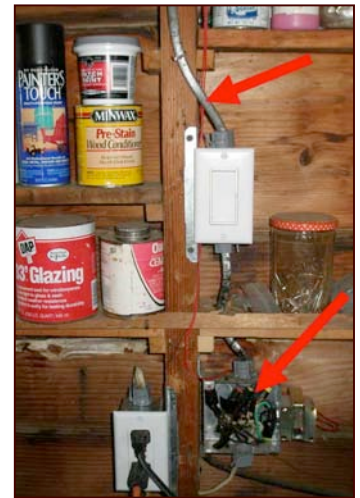
5. Exposed nonmetallic sheathed cable was observed within 7' of the garage floor (on the edges of wood framing members at the rear garage interior wall), and an electrical box without a cover plate was noted. (See the top photo to the right.) All nonmetallic sheathed cable in the garage (within 7' of the floor) should be installed within the wall bay(s) or otherwise protected from harm to conform to standard and safe installation practices. A proper cover should be installed at the electrical box to safely shield the wiring. A qualified electrical contractor should evaluate the conditions and perform the necessary corrections to assure a proper installation.

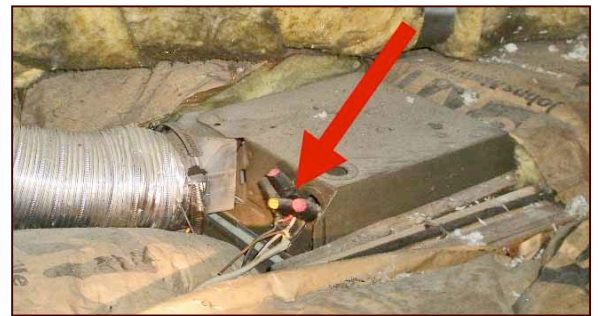
6. Exposed splicing was observed in the attic, at the front hall bathroom ceiling fan (See the bottom photo to the right). The splices should be contained in the appliance enclosure box (or in a properly installed and covered electrical box) to safely shield the wiring. A qualified electrical contractor should evaluate the condition and perform the necessary corrections.

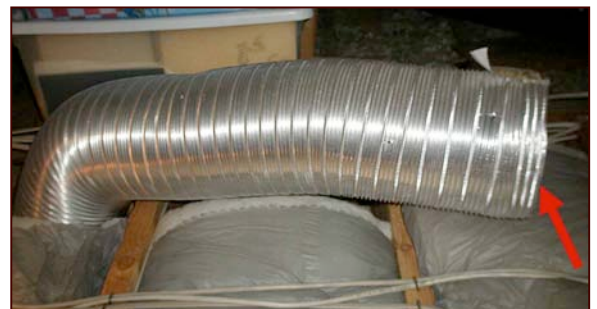
1. The duct for the kitchen exhaust fan terminated in the attic (**See the photo to the right**). The duct should be properly terminated at the exterior of the house to conform to standard venting practices, and the duct should be metal with a smooth interior wall (not corrugated flex ducting). A qualified contractor should evaluate the condition and perform the necessary corrections.

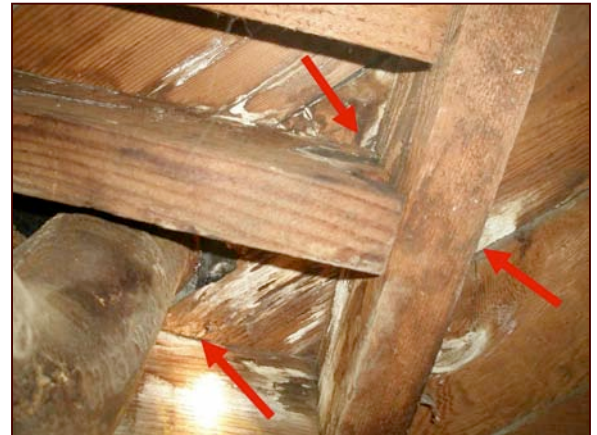
1. Leaking was observed at the showerhead connections of the front hall bathroom tub when the fixture was tested. Correction is needed to halt the leaking and to help avoid a possible worsening of the condition.
2. Possible fungus, and damage to the sub floor, was observed below the hall bathroom (**See the photo to the right**). The extent of any damage that may be present beneath the visible surfaces was not determined. A qualified contractor should evaluate the conditions. Corrections should be performed as needed to repair the damaged components. See the pest control report performed the same day as this inspection for other possible observations and recommendations regarding the above conditions.
